Hydrocarbon Fuel/Combustion- Chamber-Liner Materials Compatibility

Contract NAS 3-25070
Interim Final Report
NASA CR-185203
April 1990

Report No. KBQ-FR-1
NASA CR-185203

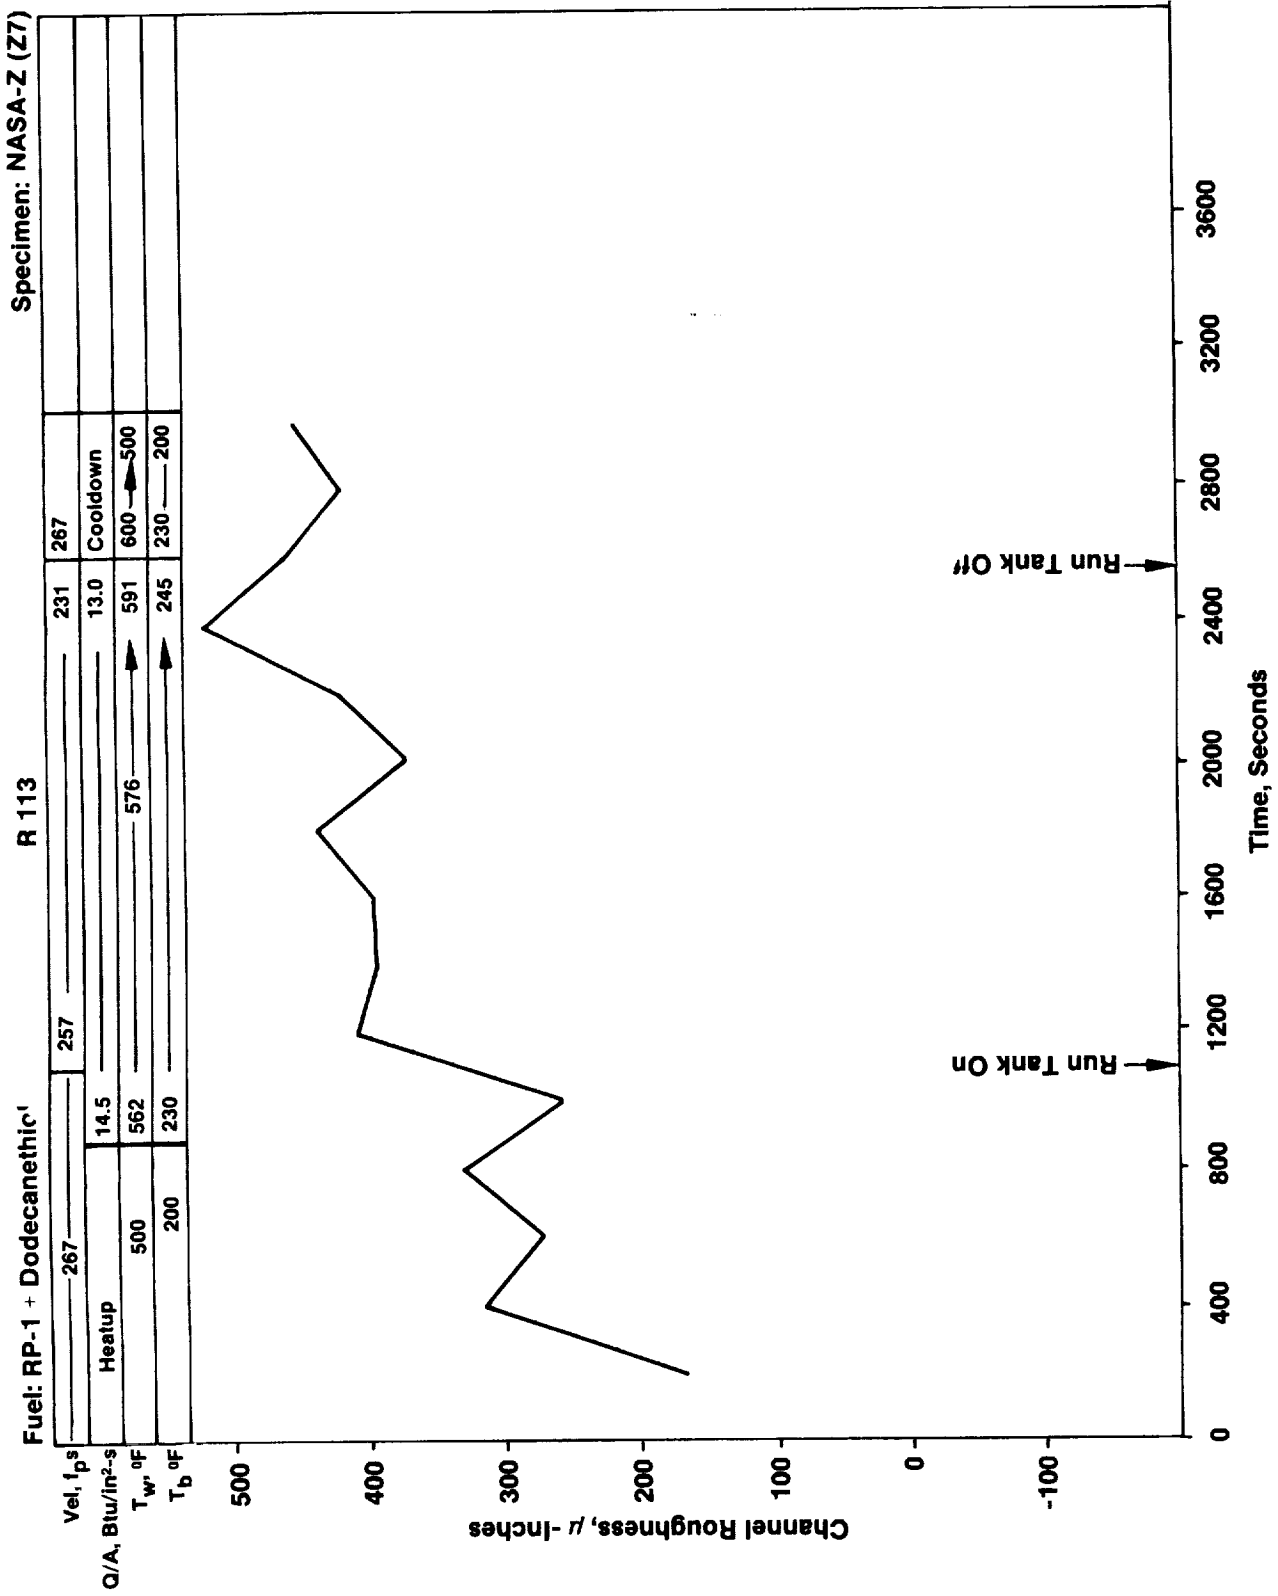
Figure 29. Apparent Channel Roughness During Run R113

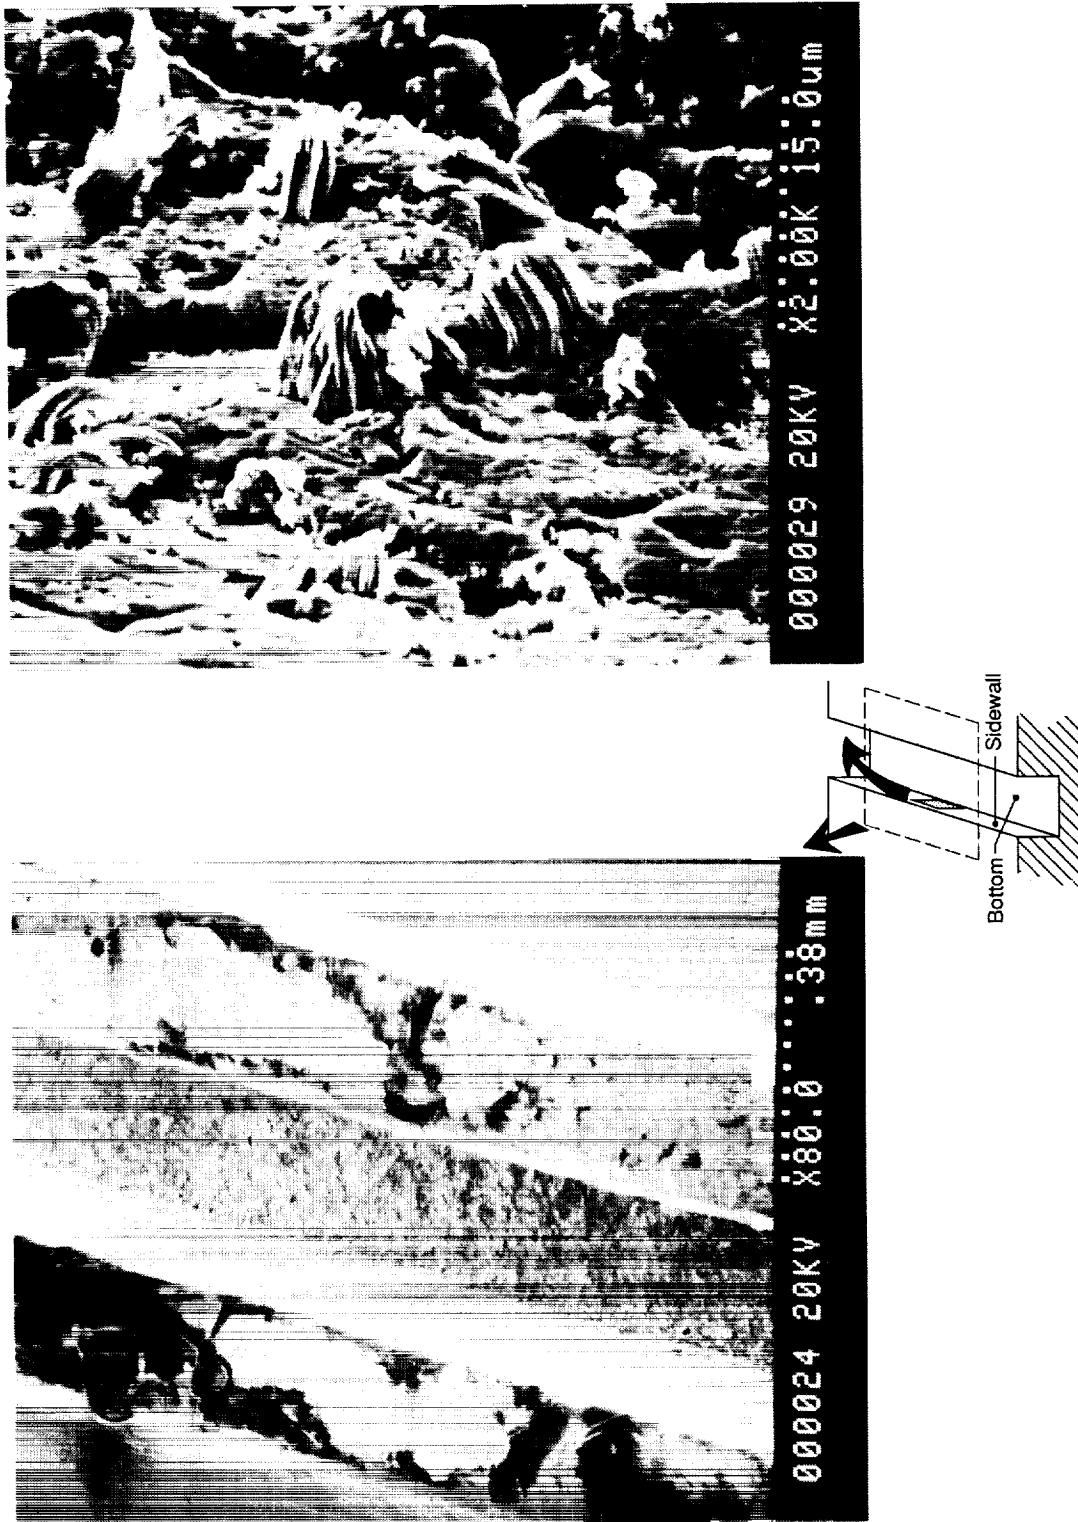
Figure 30. Addition of 50 ppm Sulfur to RP-1 Resulted in Corrosion of NASA-Z Channel, Even at Low Wall Temperature (586°F)

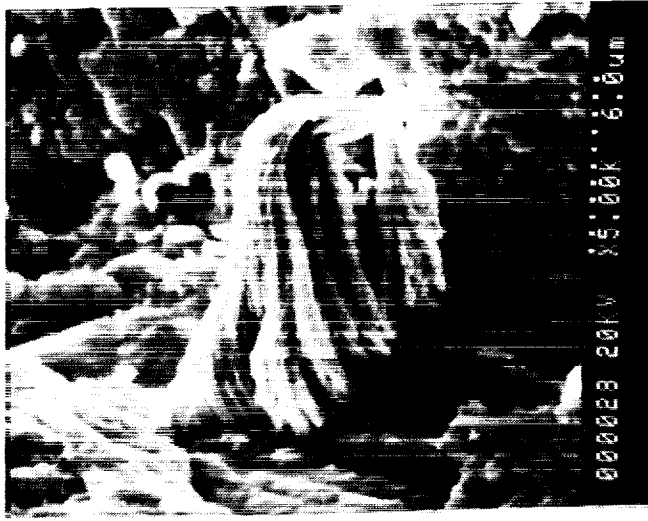
Figure 31c. Channel Wall at 5000x

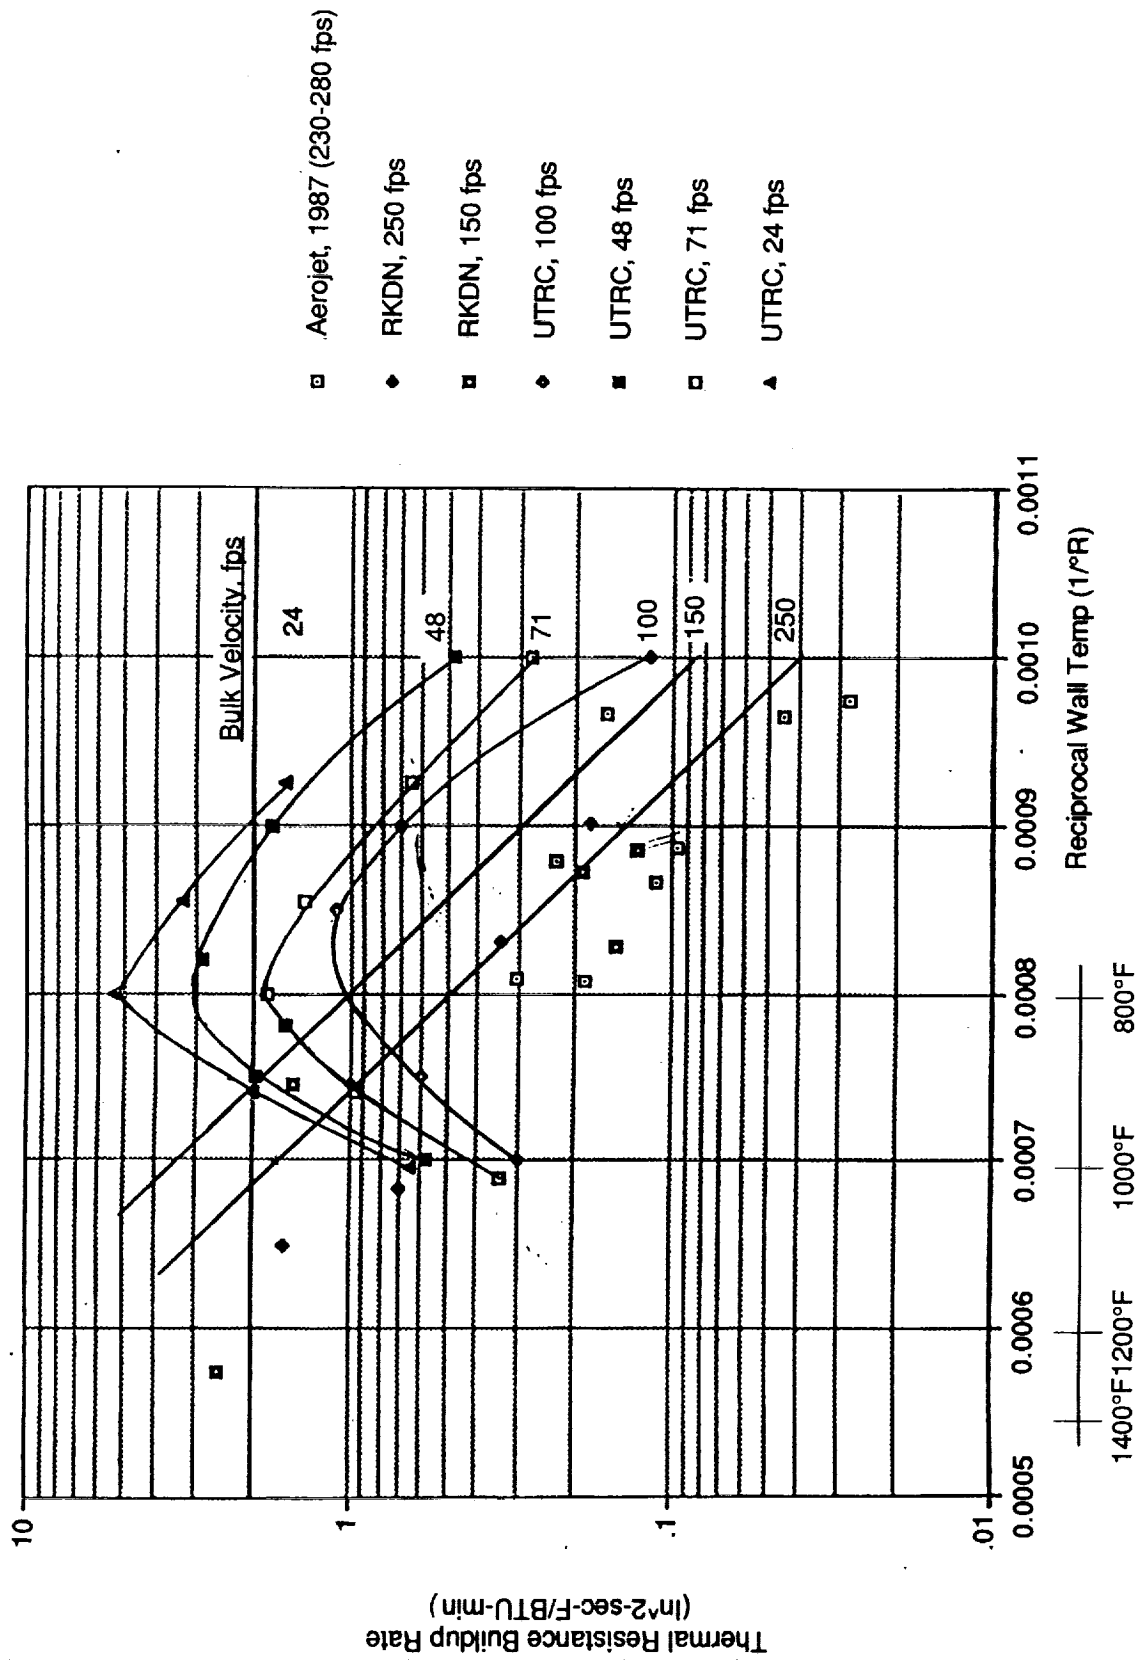
Figure 32. The Current Data on Fouling Rates of RP-1 in Copper Cooling Channels Agrees Well With Previous Test Programs

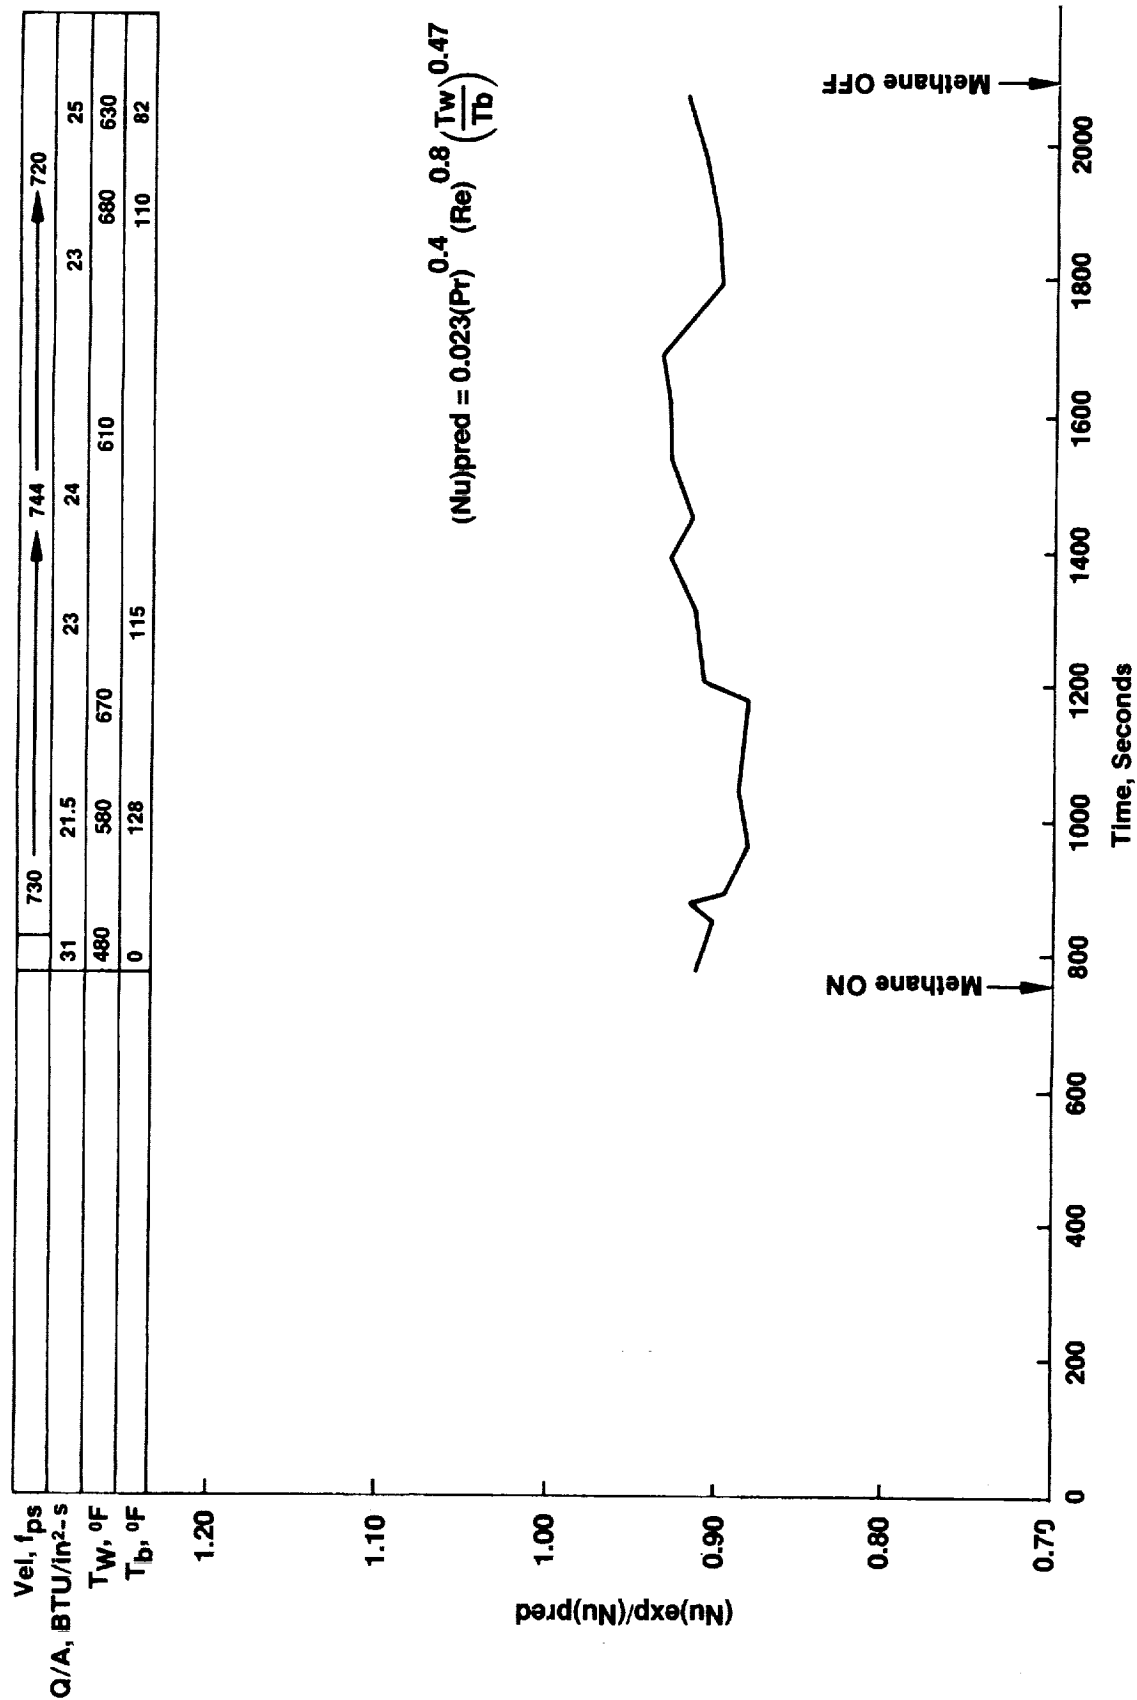
Figure 37. The Data Indicates an Insignificant Increase in Heat Transfer Coefficient Occurred During Test M103. This Behavior Was Typical of Dynamic Tests Conducted With Technical Grade Methane

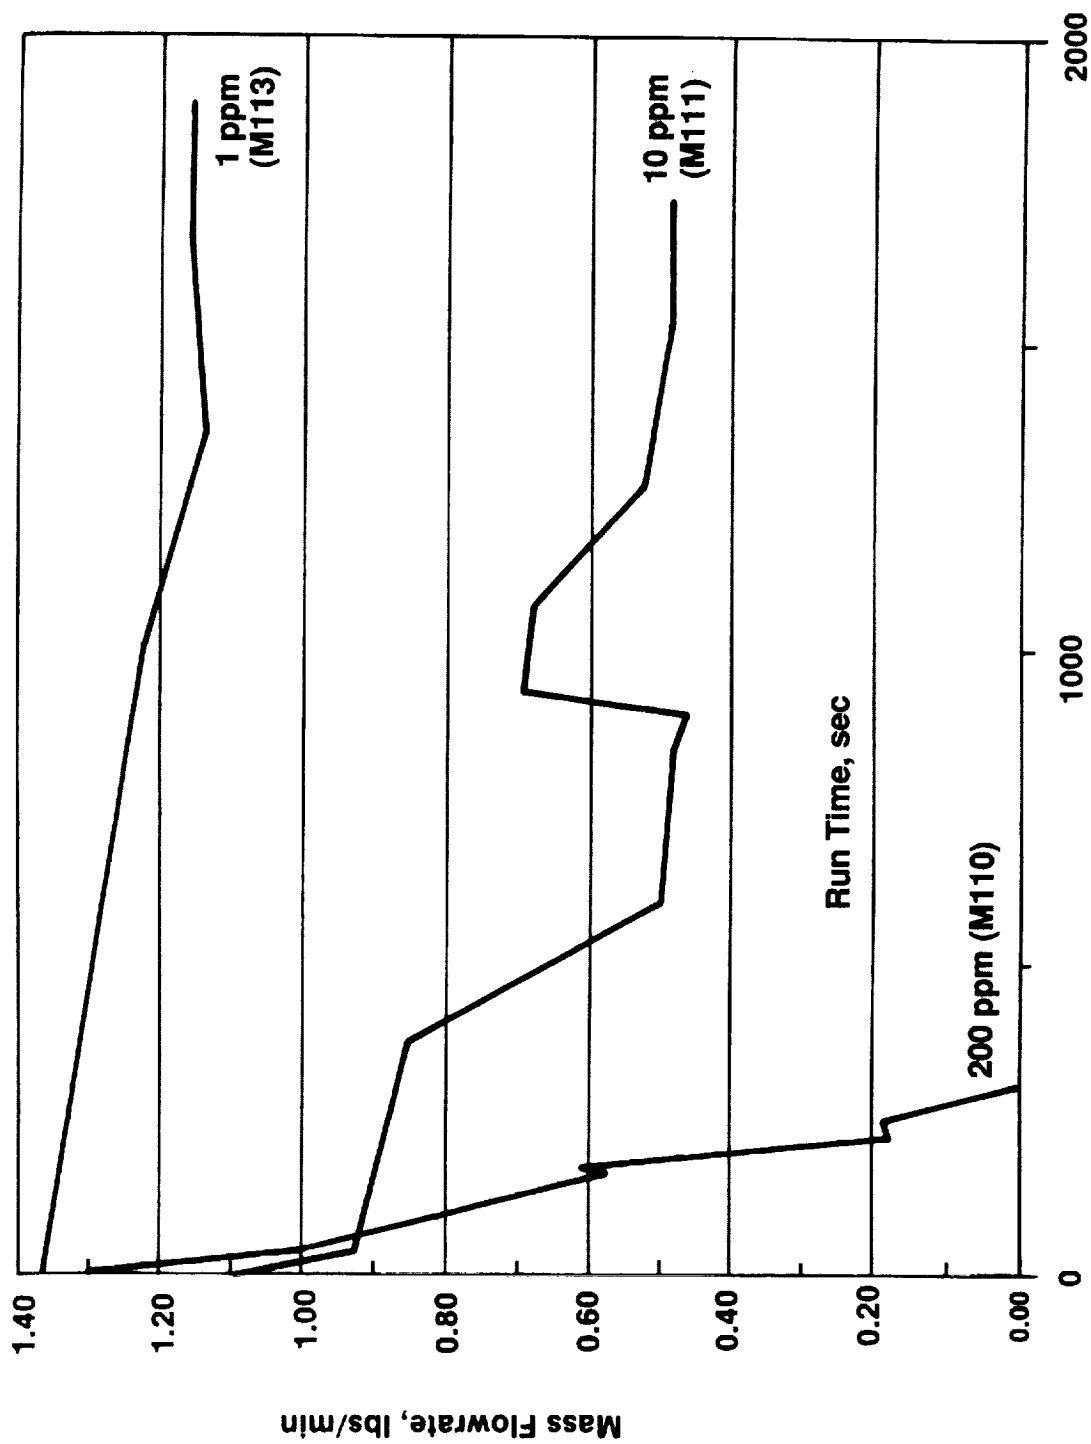
Figure 41. Sulfur in Methane Affected Flow Through Channel

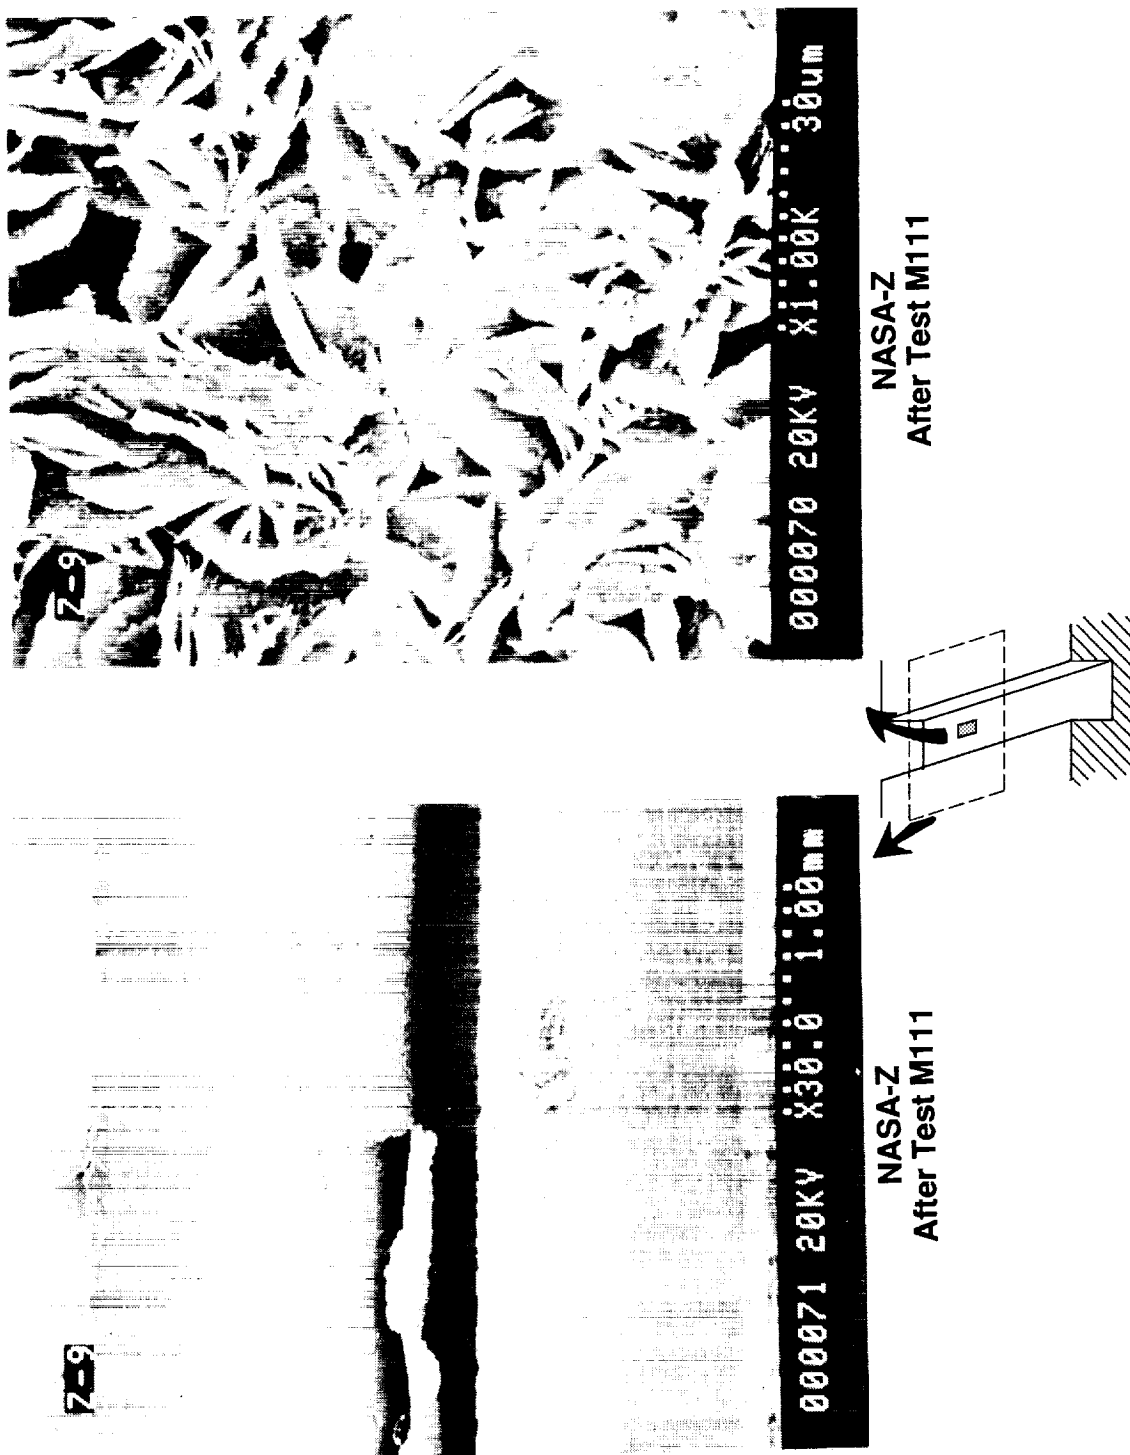
Figure 42. 10 ppm Sulfur in Methane Created Vivid Rosettes of Copper Sulfide in Test M111

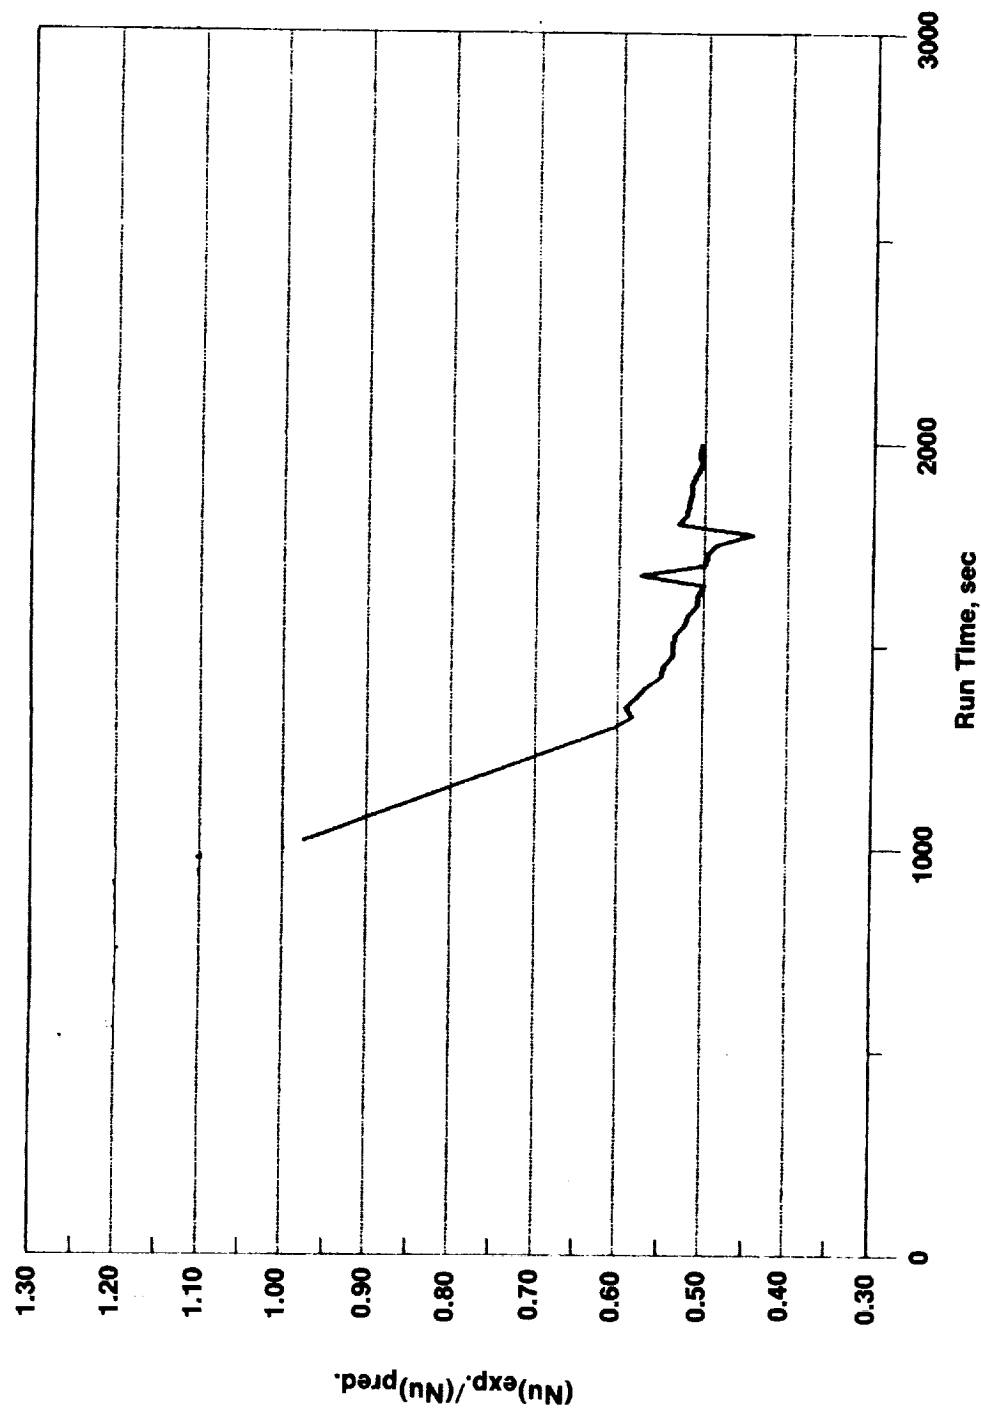
Figure 56. Heat Transfer Performance Degradation Apparent During Operation With Uncooled Propane (Test P105)

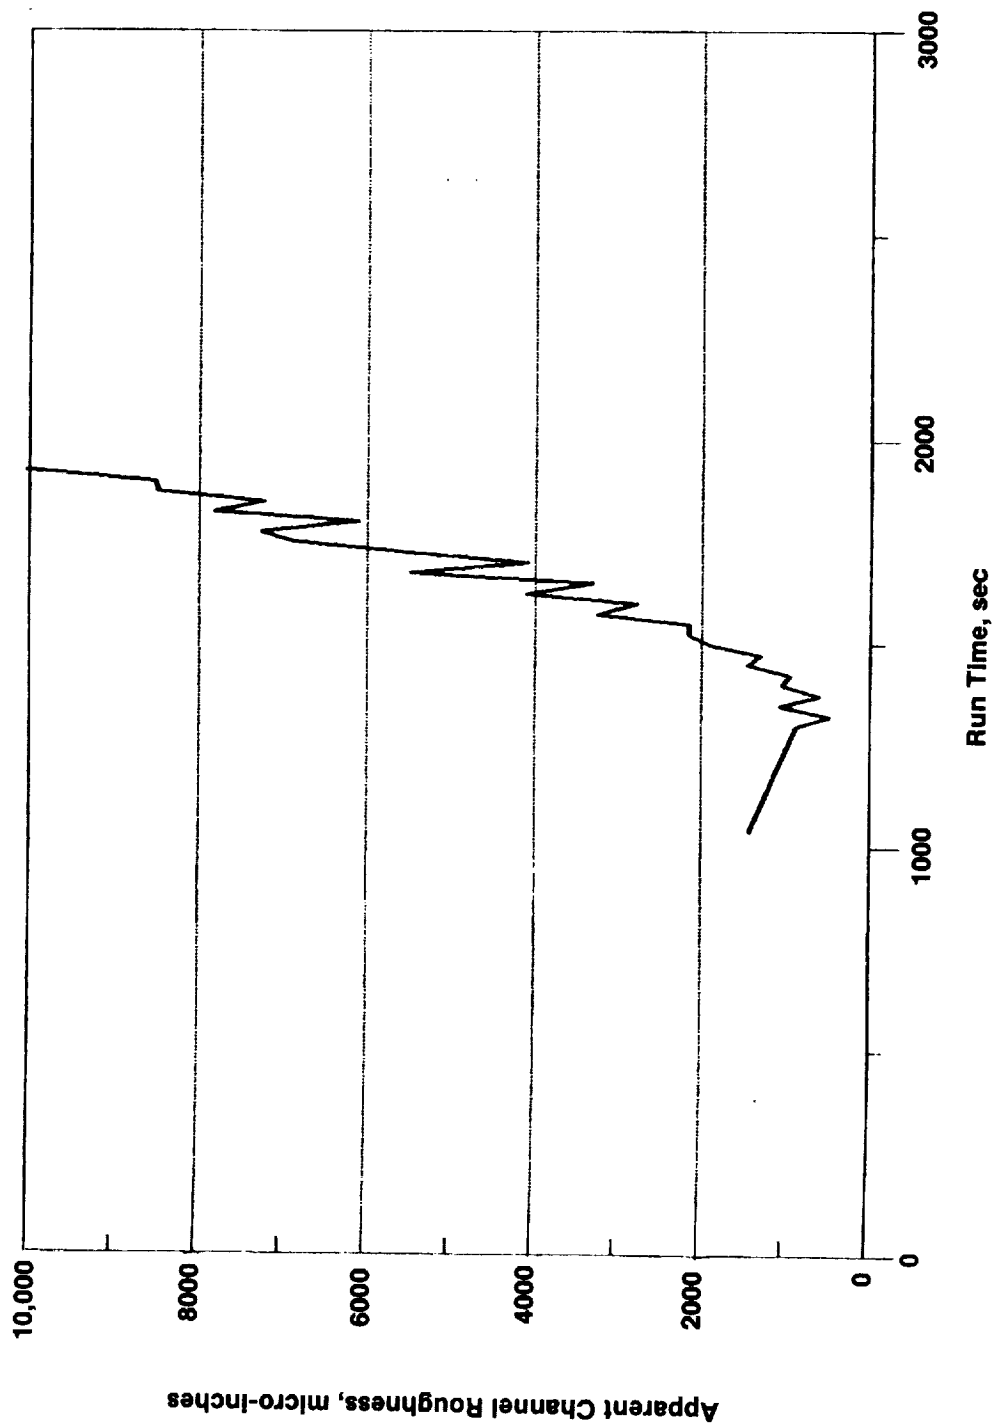
Figure 57. Flow Performance Degradation Apparent During Operation With Uncooled Propane (Test P105).

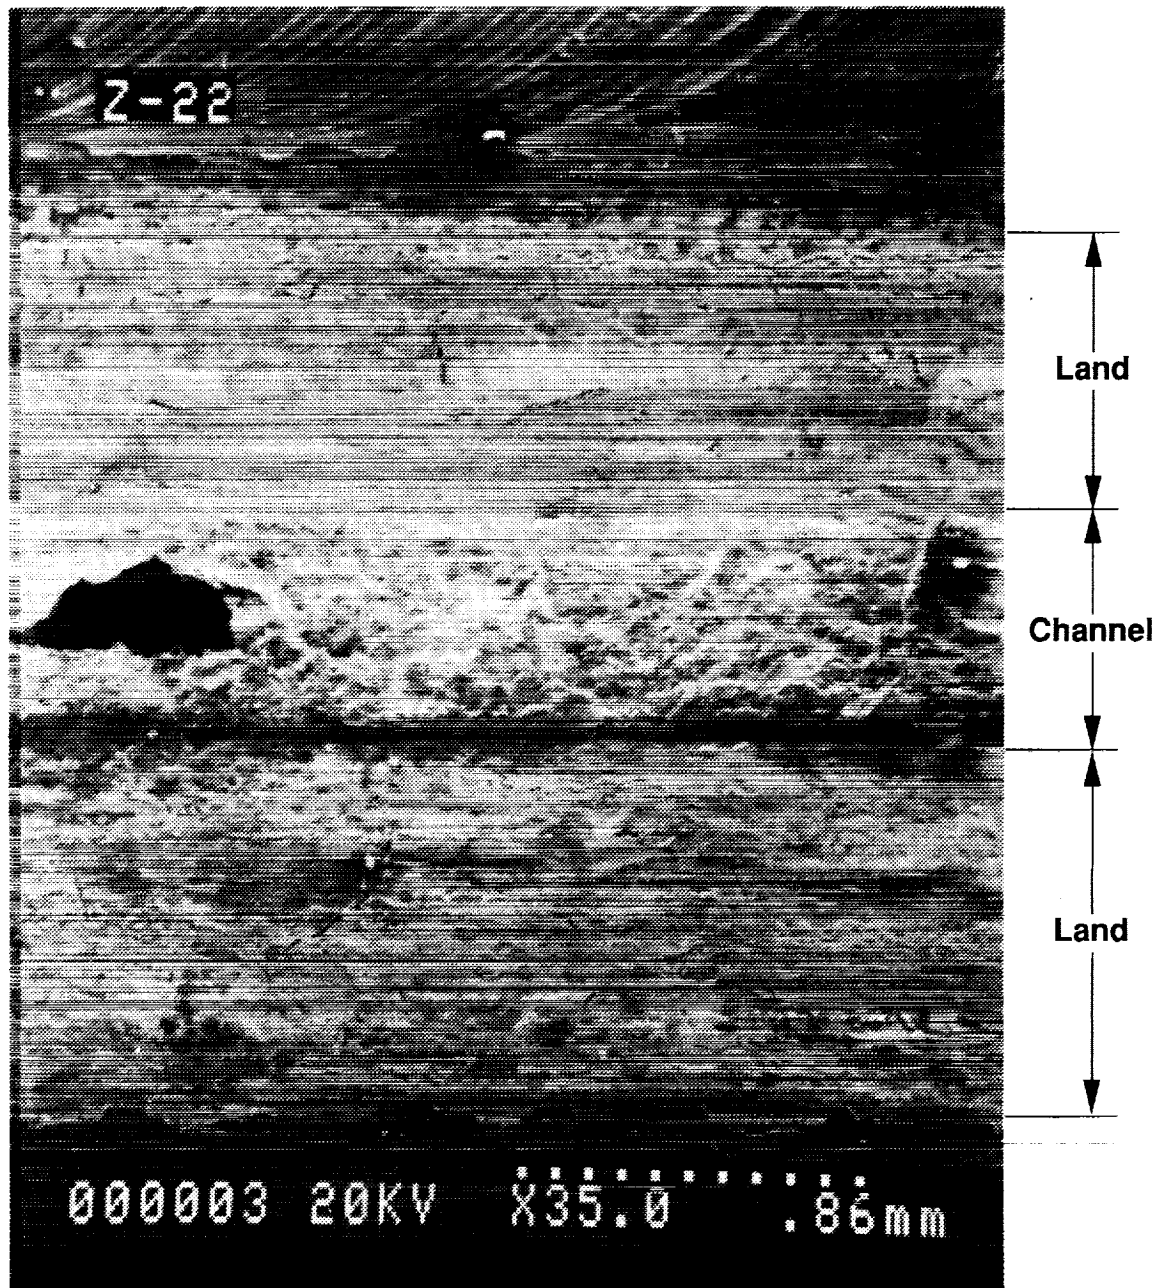
Figure 59. SEM Photo Shows Material Which Bridged Channel During Run Using Sub-Cooled Propane at Low Velocity (Test P106)

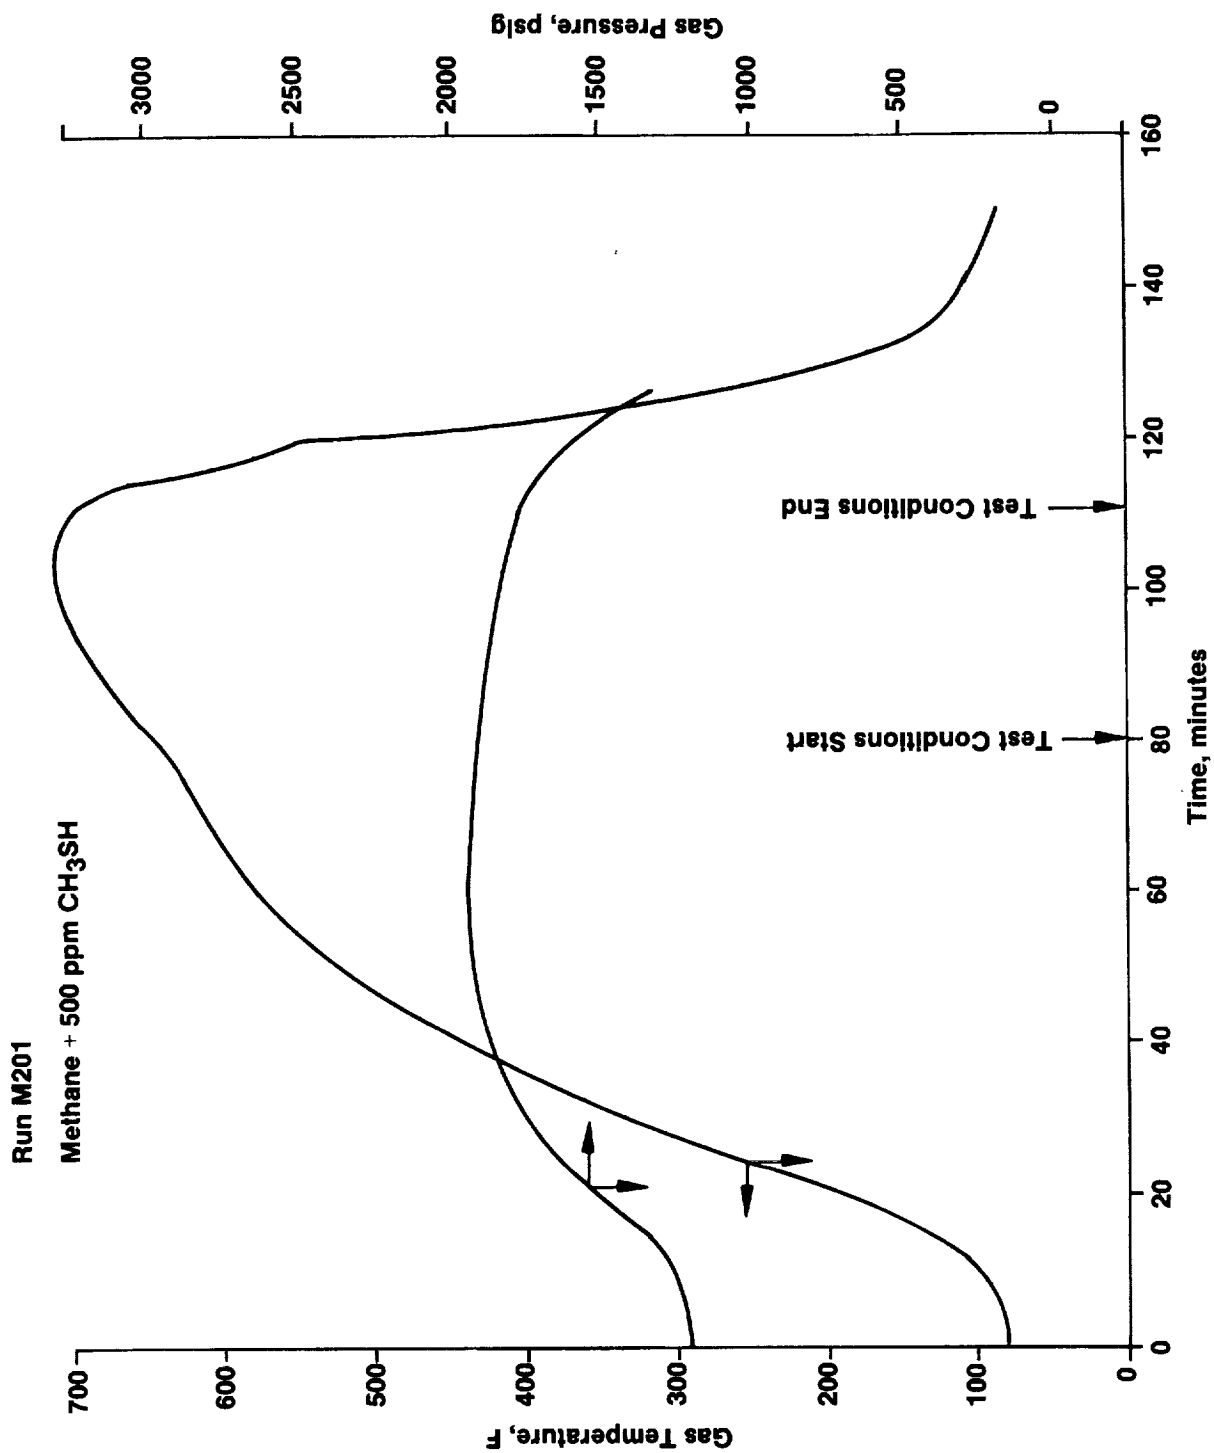
Figure 61. Temperature and Pressure Measurements of Test M201 Indicate Slow Leak in Bomb Seal

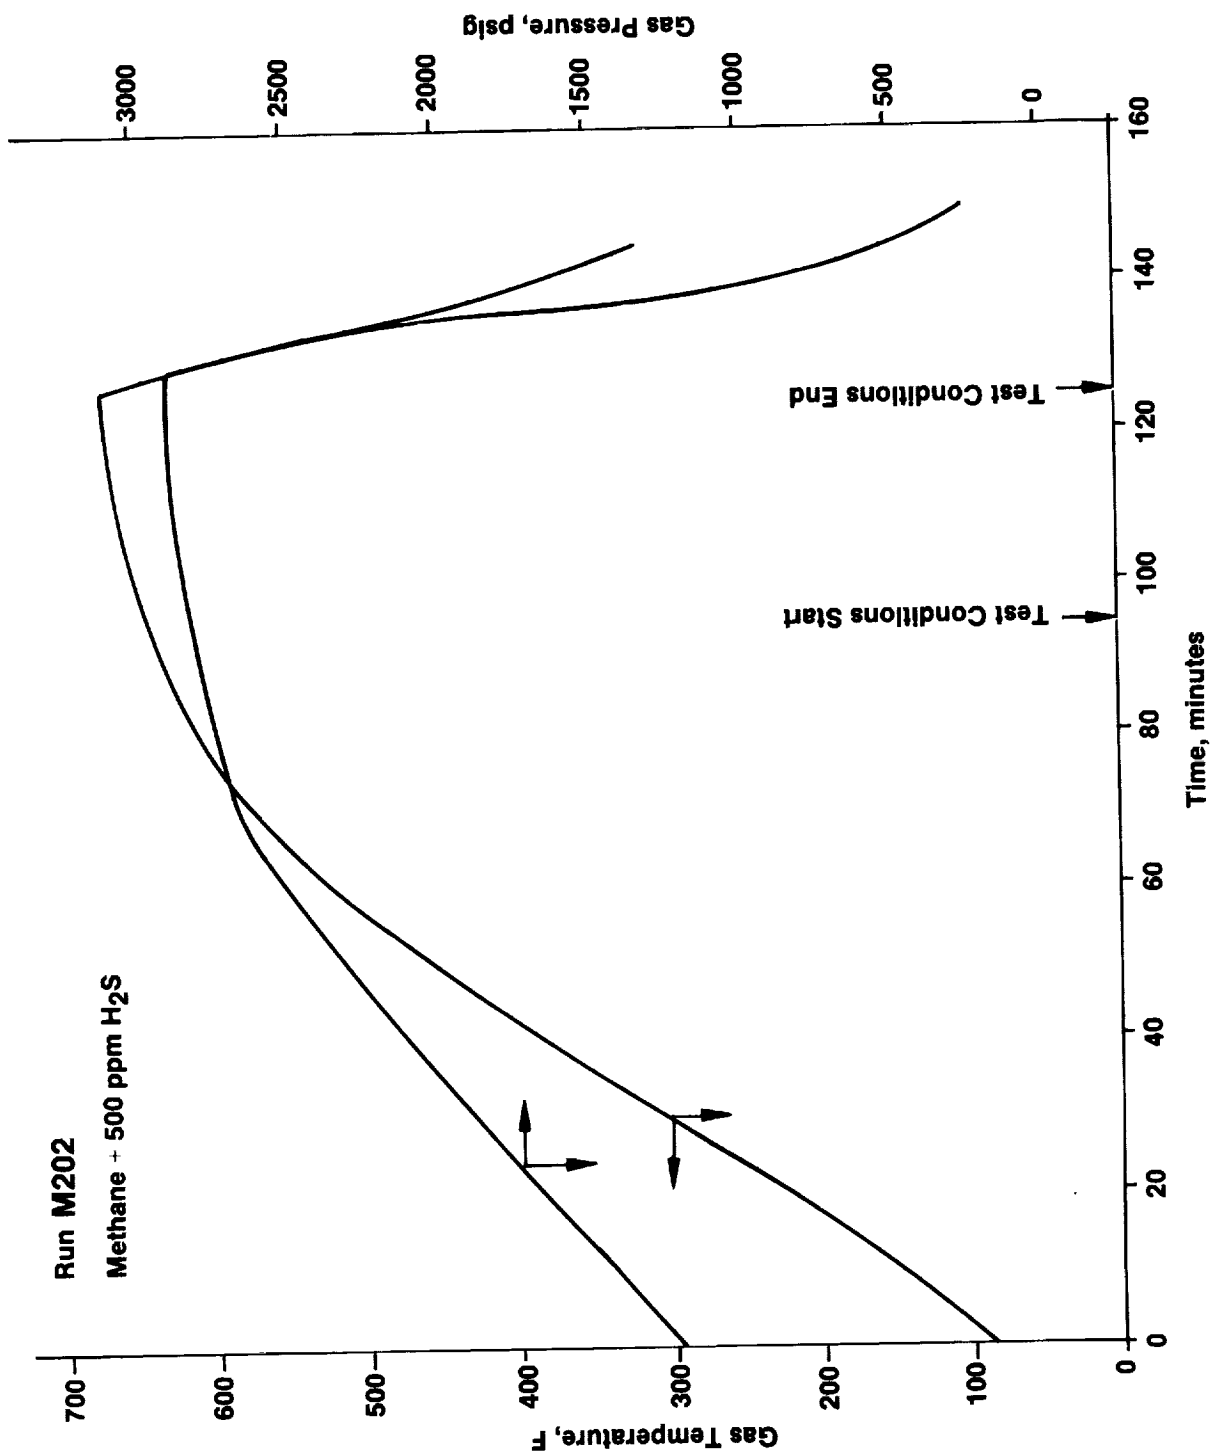
Figure 70. Temperature and Pressure Traces of Static Test M202

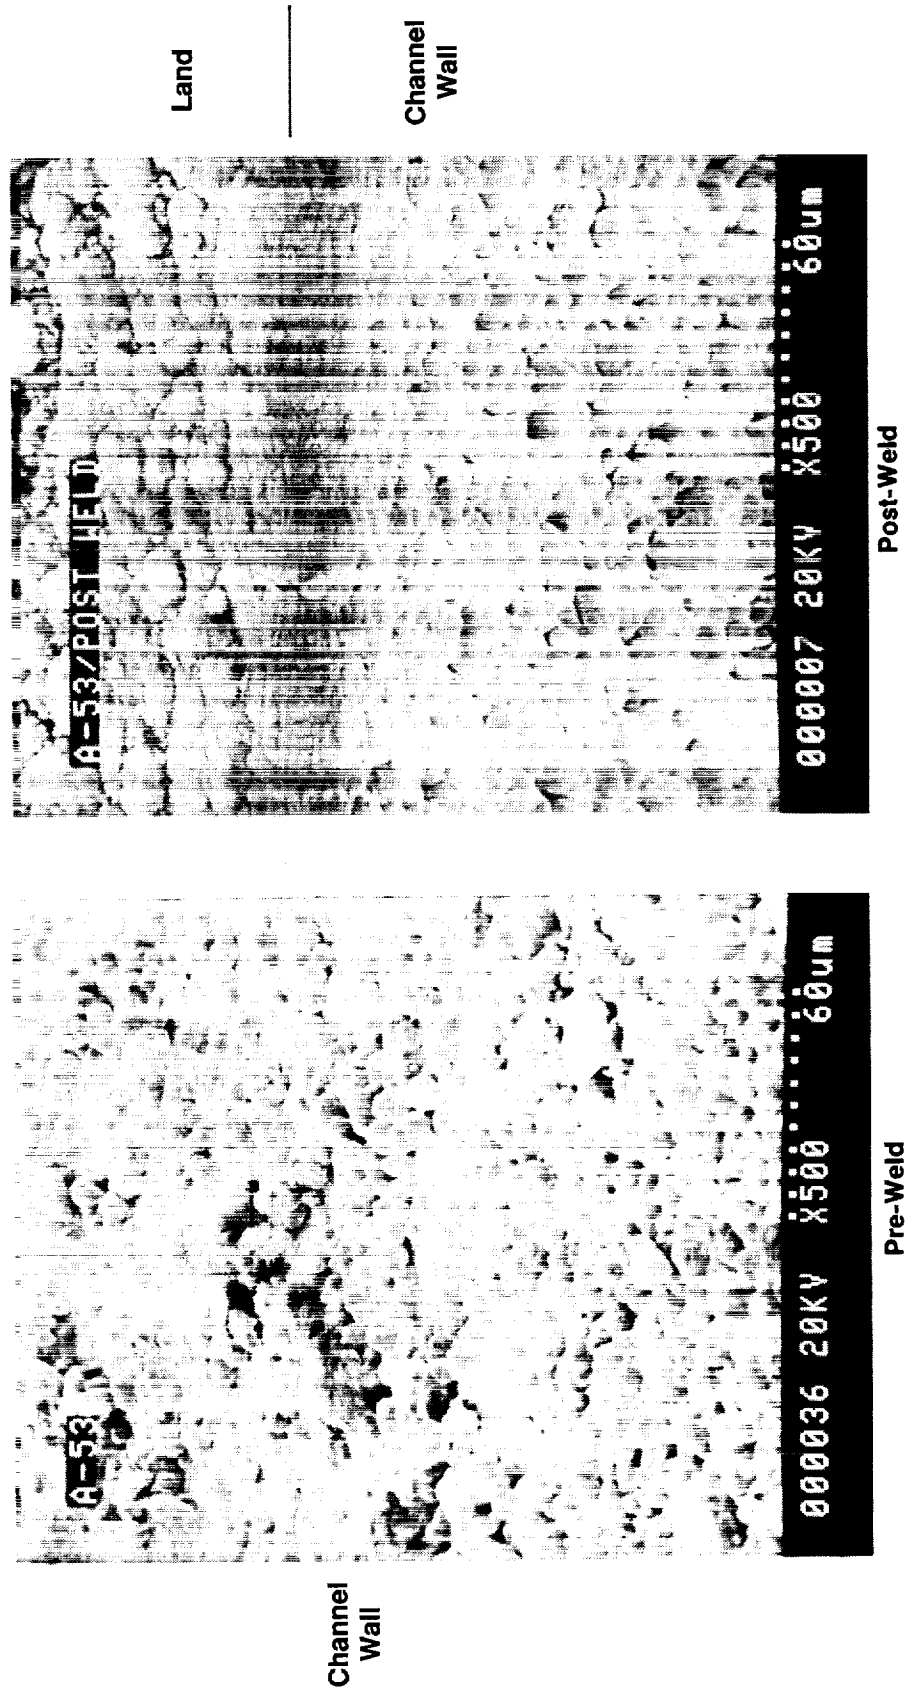
Figure 81. No Difference Was Apparent in the Gold Coating as a Result of Welding on the Channel Closeout

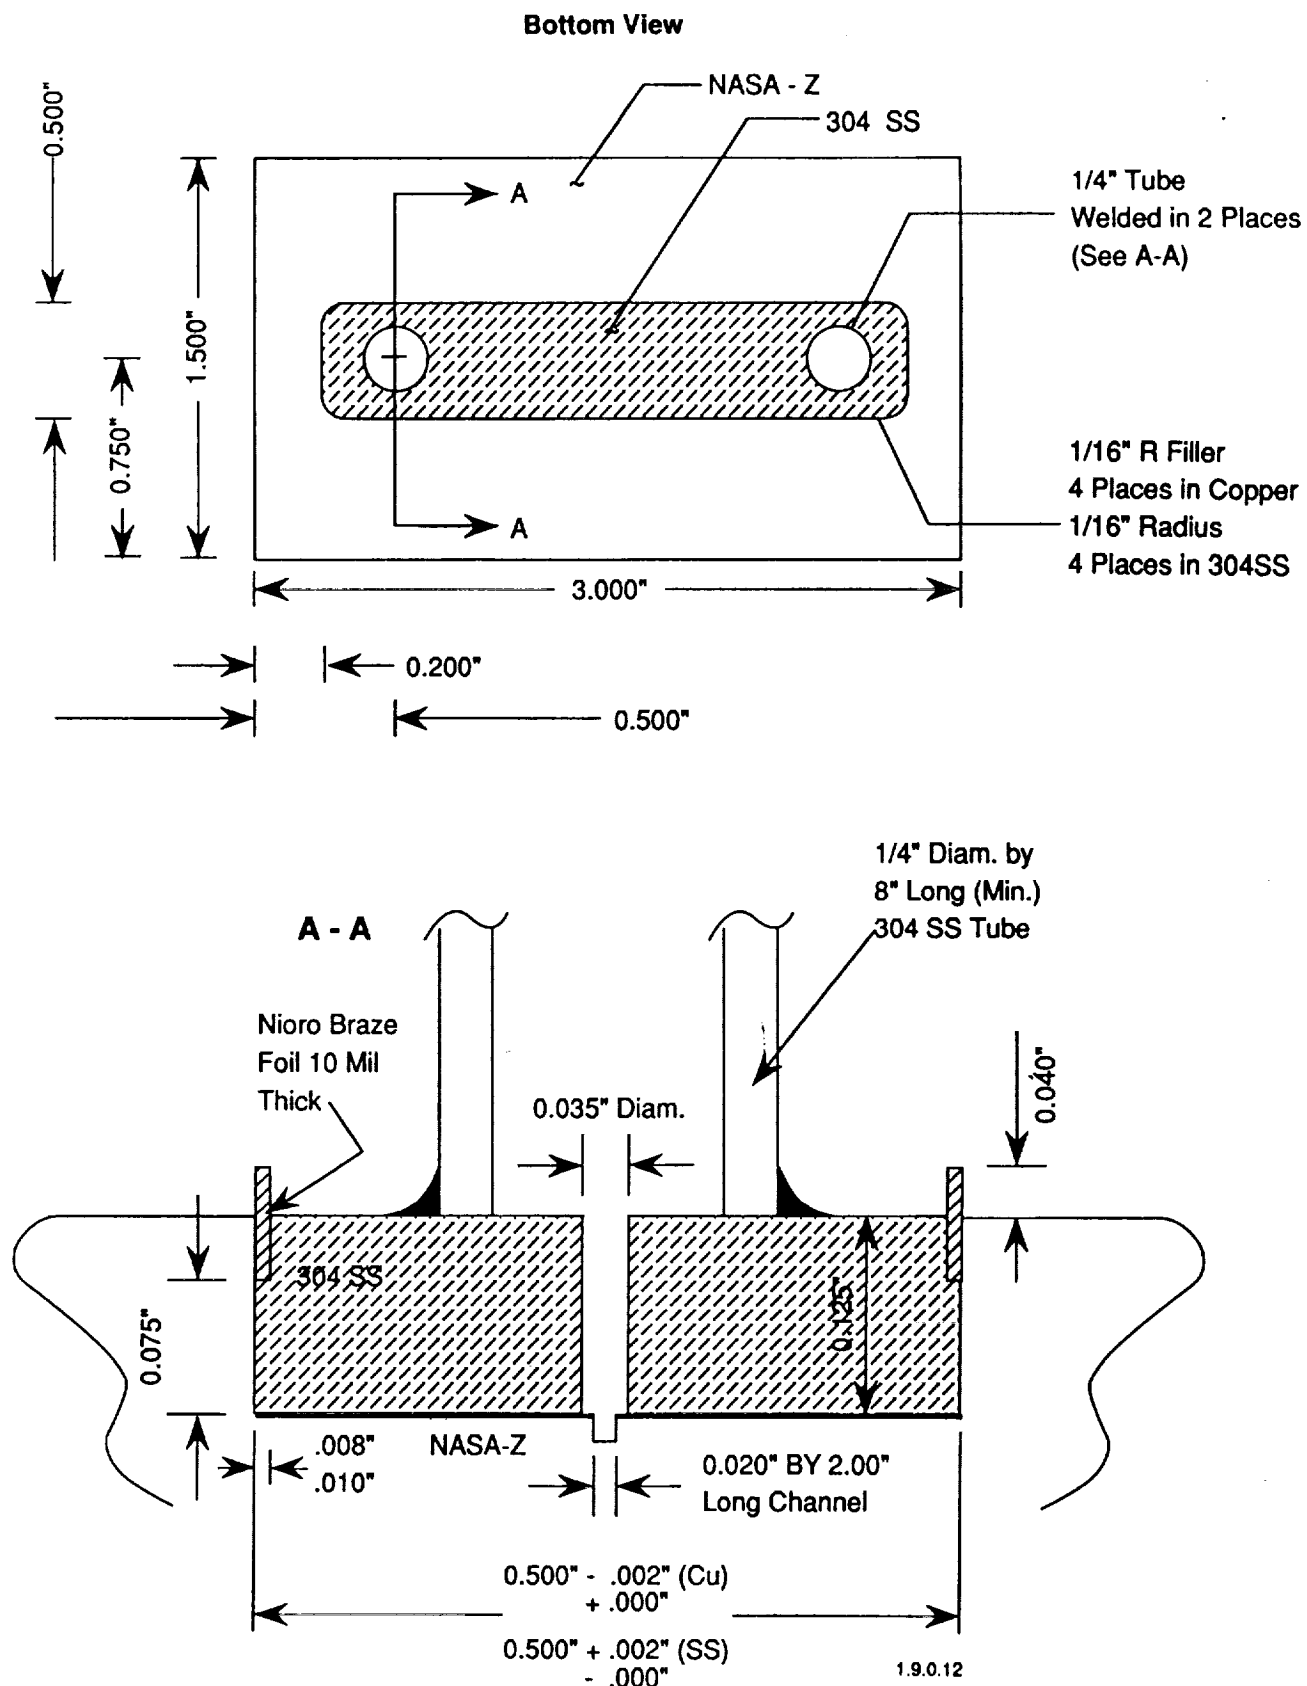
Figure 83. Revised Test Specimen Design Used in Tests M207 and M208 Eliminated Contact Between Fuel and Unprotected Copper Surfaces
